# **Intel® Ethernet Controller 82571EB/82572EI/82571GB/ 82571GI Specification Update**

**Networking Division (ND)**

**Revision 6.8  
November 2014**

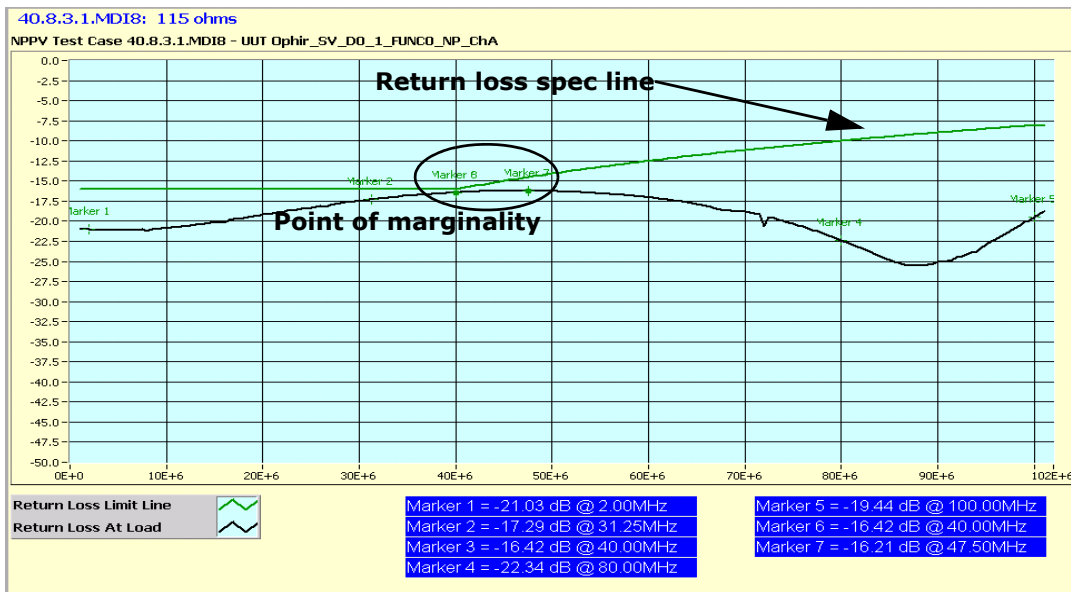
Return loss for 115 ohm load is marginal (Gigabit IEEE specification Section 40.8.3.1) near the frequency of 40MHz. Return loss is acceptable throughout the rest of the frequency spectrum and conforms to the 10Base-T and 100Base-TX specification limits.

IEEE conformance is marginal. There is no impact on system-level performance.

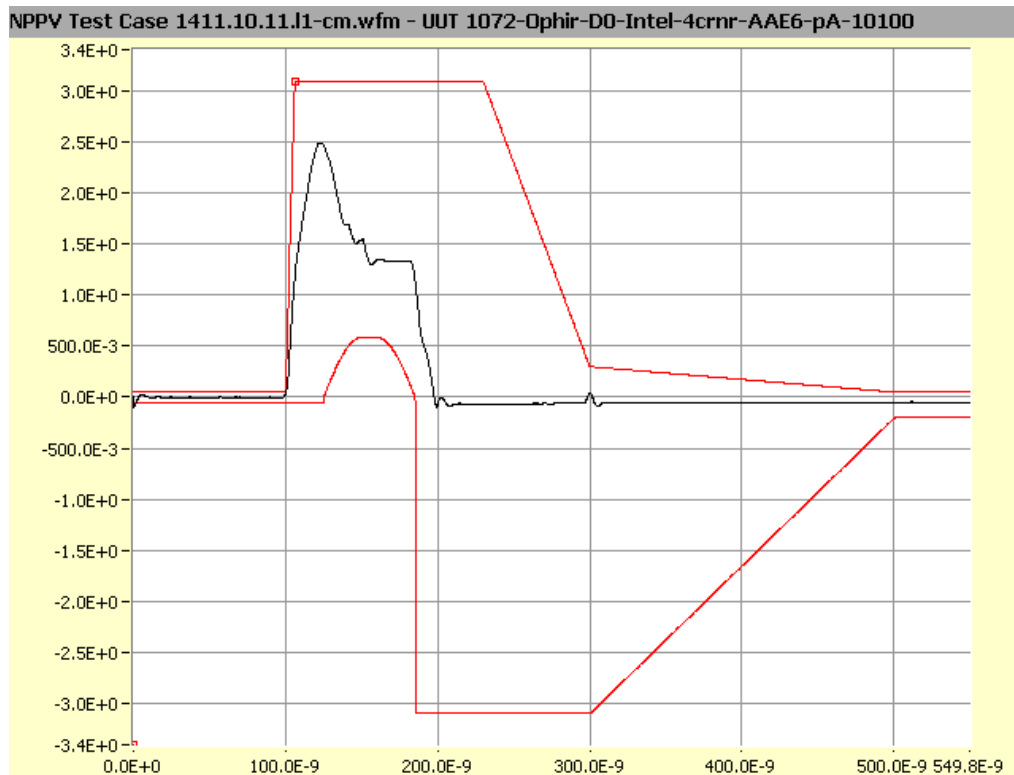
The 10base-T link pulse touches the template due to voltage ripple/glitch.

Compliance with the specification is not complete, however, there is no effect at system level.
